University of Pardubice
Faculty of Transport Engineering

**METHODOLOGY OF
EVALUATION OF THE
CONDITION OF FLEXIBLE
CLAMPS SKL14 IN OPERATED
LINES**

Thesis

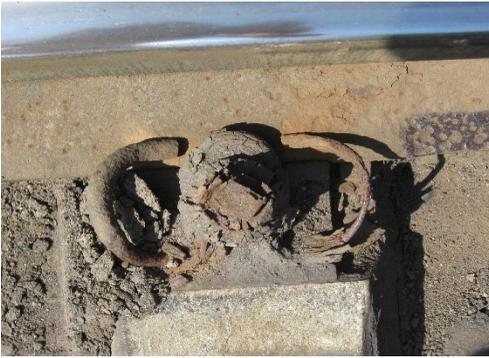
Fig. 1-1: Clamp with large corrosion loss of material

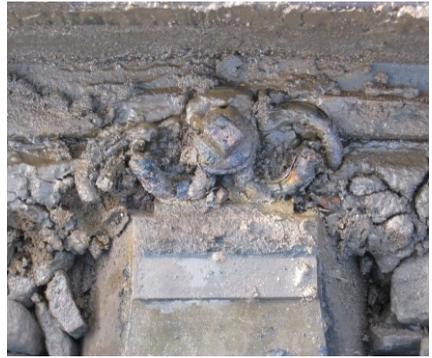
Fig. 1-2: Cracked clamp

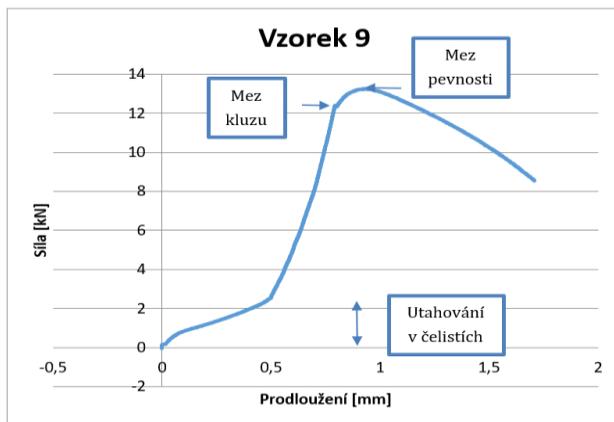
The measuring device was Zwick Z030. A test specimen was clamped in the jaws and a loading cycle was started with a step of 0.002 s^{-1} , which was controlled and recorded by a PC, specifically with the Zwick testXpert Master program. The results were exported in the format of path in mm and force in kN and subsequently evaluated in Microsoft Excel - see Fig. 4-2.

Fig. 4-2: Record from tensile test

Yield strength values were found in the range of 1289 to 1376 MPa, limit of strength values in the range of 1392 to 1492 MPa. If the determined values are compared with the values according to ČSN EN 10089, which are given for the steel from which the clamp is made (38Si7), i.e. the yield strength of 1150 MPa and the limit of strength between 1300 and 1600 MPa, it is clear that the limit values yield strengths are above the values specified in the standard, the values of the limit of strength are then within the limits specified by the standard.

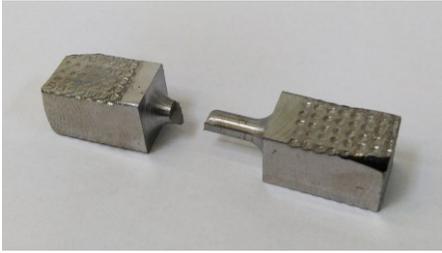
Fatigue tests were performed on material samples removed from the clamps - see Fig. 4-3. The measuring device was an INOVA electrohydraulic system using the AH100-40 cylinder. A test specimen was clamped in the jaws and harmonic loading was triggered - see Fig. 4-4.

Fig. 4-3: Sample after fatigue test

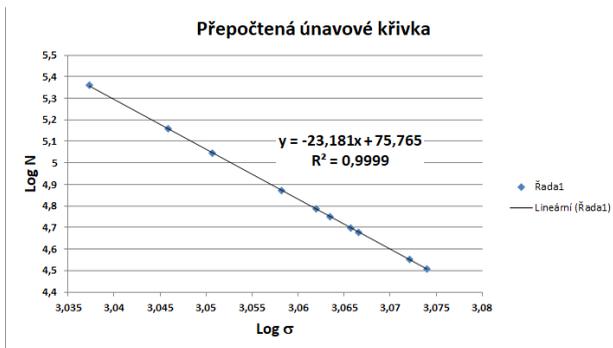
The mean value of the oscillation was chosen to be 4 kN due to the stability of the system. The loading frequency was 10 Hz. The resulting relevant values of the number of cycles to fracture were tabulated and a fatigue curve was constructed, which were subsequently transformed to a zero mean value according to Goodman. The characteristic values of the fatigue curve were found to be $m = 23.181$ and $\log c = 75.765$ - see Fig. 4-5. The contractual fatigue limit at zero mean value determined by the Smith chart was 997.56 MPa.

Fig. 4-5: Fatigue curve

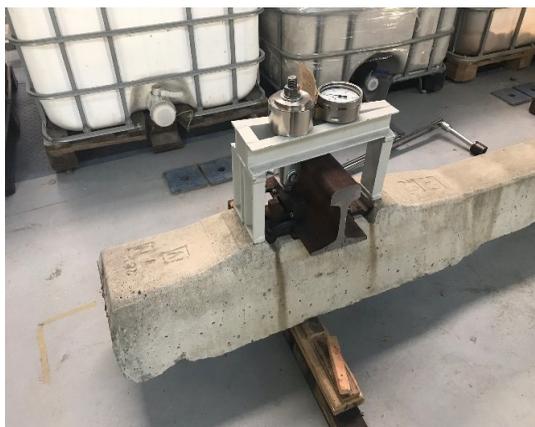
A jaw is mounted on the outer arms of the clamp, which ensures that these arms are pulled upwards. The clamp is tightened to the prescribed torque, 200 Nm was applied for measurement purposes. Subsequently, a frame is placed on the sleeper, on which the load cell is attached. By tightening the screw, the outer arms of the clamp are lifted and at the moment when it is possible to insert a 0.1 mm flat gauge under the clamp arm, the value on the load cell is read. See Fig. 4-6.

Fig. 4-6: Vossloh device for measuring of the clamping force

A value is read and recorded for each outer arm, i.e. two values are recorded for one clamp. Subsequently, the values are averaged and the resulting average is multiplied by a factor of 0.88. This coefficient is determined by the manufacturer of the test equipment, it serves to compensate for the different geometry of the test equipment (different lever arms). 10 new clamps were

Implemented by Vossloh device - see Fig. 4-6 - on clamps with different degrees of corrosion attack. The degree of corrosion attack was given by the remaining wire thickness after corrosion cleaning (mechanical cleaning). For reasons of comparability / comparison, clamps from other line sections were also included in the measurement. Values confronted with the experimentally found - wire diameter min. 12 mm and clamp weight min. 470 g (clamping forces min. 8 kN taking into account a tolerance of ± 0.5 kN). The results are as follows: Žst. Kolín - 21 samples, passed 3; Dobříř - 31 samples, passed 4. The criterion determined by the methodology was confirmed, the diameters of the wires, the weights and the clamping forces corresponded to the criteria. Poříčany - 8 clamps, 2 failed; TÚ Český Brod - Poříčany - 8 clamps, 5 failed. The influence on the clamping force was not dominated by corrosion loss of the material of flexible clamps (clamps without significant corrosion loss), but the effect of repeated loading, the clamps were removed from a heavily loaded track by railway traffic, where they were stressed for 15 years.

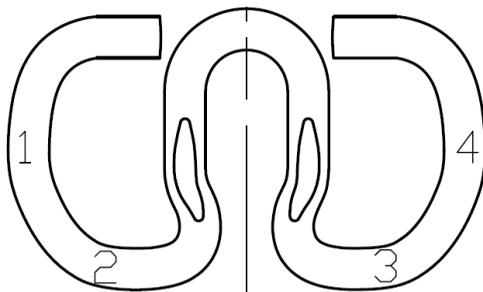
By Vossloh device 10 clamps were measured with different levels of corrosion. For these clamps, the diameters of the clamp wire were measured at 4 locations - see Fig. 4-7 and the weight of the clamp was measured. According to [9], the required value of the clamping force is min. 8 kN (measurement according to the standardized procedure according to ČSN EN 13146-7). Due to the difference in procedures and measurement method, a

Fig. 4-7: Marking of places for measuring the wire diameter of flexible clamps

tolerance of ± 0.5 kN was considered. From the measured values of clamping forces and corresponding measurements of wire diameters and clamp weights, it can be deduced that if the wire diameter at any measured point 1 to 4 is less than 12 mm and the clamp weight is less than 470 g, then the clamping force value does not meet the requirements [9] taking into account the tolerance considered. The wire diameter of the new clamp is 13 mm, the weight of the new clamp is approx. 492 g.

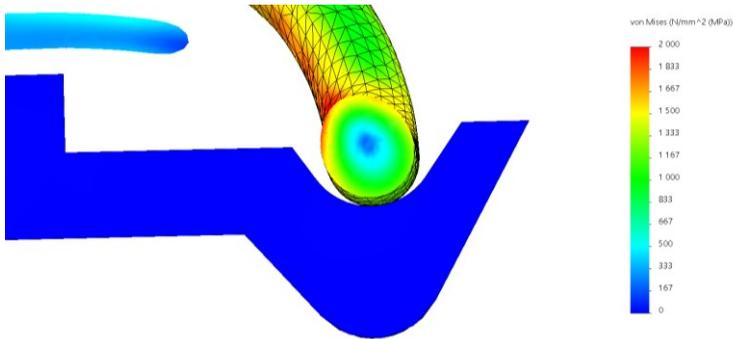
modelled only when tightened to the prescribed torque under different compressions of the clamps given by different reference geometries (12.6 mm to 13.4 mm by 0.2 mm). Sections were made at the locations of the strain gauges (see 7.2.2) and changes in stress along the cross section of the clamp were found - see Fig. 5-1.

Fig. 5-1: von Mises stress in section at point 2

Higher values are achieved when tightening the clamp in place at the angular guide insert. It is clear from the obtained values that von Mises stress values of up to 1900 MPa were achieved during tightening, the stress values gradually decrease towards the center of the clamp, where values of approx. 100 to 200 MPa are achieved. The clamp will not be damaged during tightening with the prescribed tightening torque, even if the strength limit is locally exceeded (according to [4] it is 1300 MPa to 1600 MPa, verified by tensile test). High stress in the surface layer reduces the corrosion or fatigue resistance of the clamp. The results are summarized in Tab. 5-1.

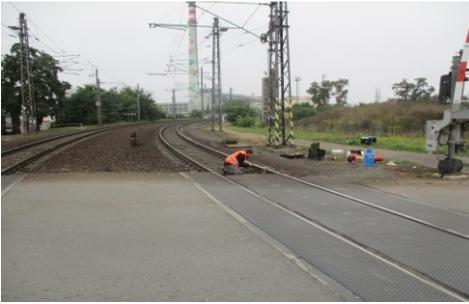
The measuring point is located in a curve with a radius of 190 m with an elevation of 56 mm and a speed of 50 km/h located on the line 502A Kolín – Nymburk – see Fig. 7-1 and Fig. 7-2. The location was chosen due to the faults that occur in the location (slip waves, cracking of the clamps, etc.).

Fig. 7-1: Place of measurement in Kolín railway station

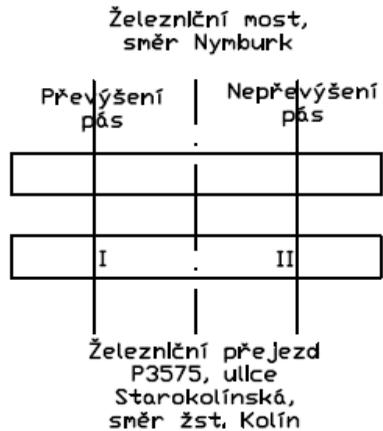
Fig. 7-2: Track markings

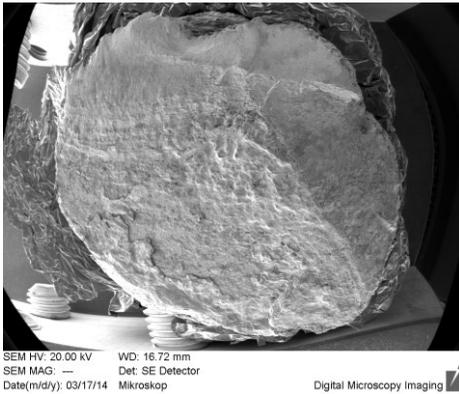
The fracture surface of the clamp from the crossing in Kolín, which did not completely break the outer arm, was examined by electron microscopy. The aim of this investigation was to find out which fracture caused the clamp to fail. It was found that the sample was fatigue damaged with multiple sites of initiation - see Fig. 7-3 and Fig. 7-4. This finding is very important for finding possible causes of why a given quarry occurs. The fracture occurred despite the fact that the clamp was not loaded for a long time (the clamps were in operation for 3 years) and there was no noticeable large corrosion loss.

Fig. 7-3: Sample for fractography

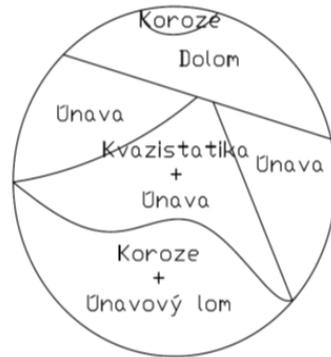
Fig. 7-4: Sample for fractography - findings

Within the methodology, further detailed analyses were performed leading to the above-mentioned facts. It was mainly a fractographic analysis of the fracture surfaces of the clamps, where it was found that these are fatigue failures (there is no plastic behaviour). From the point of view of fatigue damage, the high static preload caused by tightening the clamps to the prescribed tightening torque also plays a role. These stresses at the fracture site reach approx. 990 MPa. The experimentally obtained values were

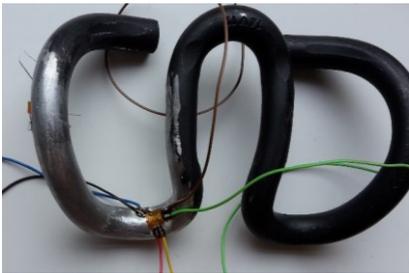
Measuring clamps (in the number of 2 pieces) were fitted with strain gauges in two different positions (a total of 4 pieces of roses). The positions of the sensors were chosen with regard to the places of greatest stress according to the FEM calculation of the manufacturer, the company Vossloh and with regard to the statistical evaluation of damaged clamps after 3 years of operation - Fig. 7-5 and Fig. 7-6.

Fig. 7-5: Strain gauge location - place II

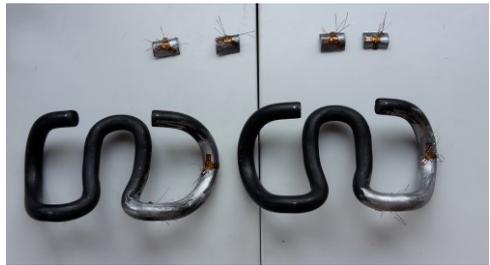
Fig. 7-6: Strain gauge location - place I

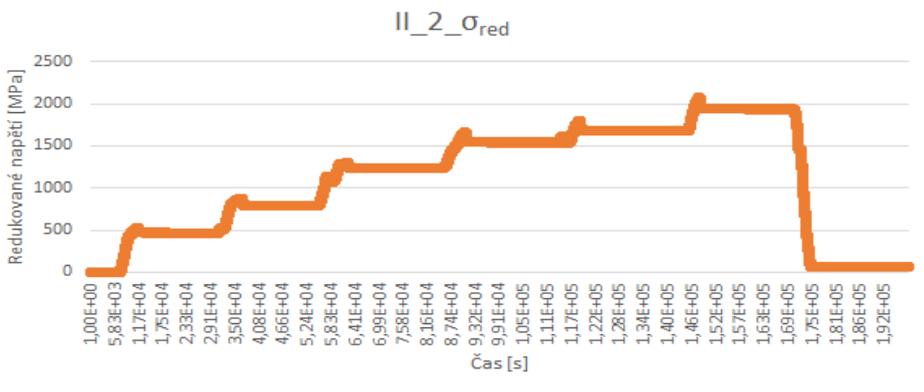
The stresses on the clamps were measured during tightening, when the clamp was gradually tightened to 50, 100, 150, 180, 200, 220 Nm and then completely loosened, resp. allowed to a value of 200 Nm. Tightening was performed with a calibrated torque wrench with an alarm clock. An example of a record is shown in Fig. 7-7. The determined values of reduced stresses are given in Tab. 7-1.

Fig. 7-7: Record of flexible clamp tightening measurements

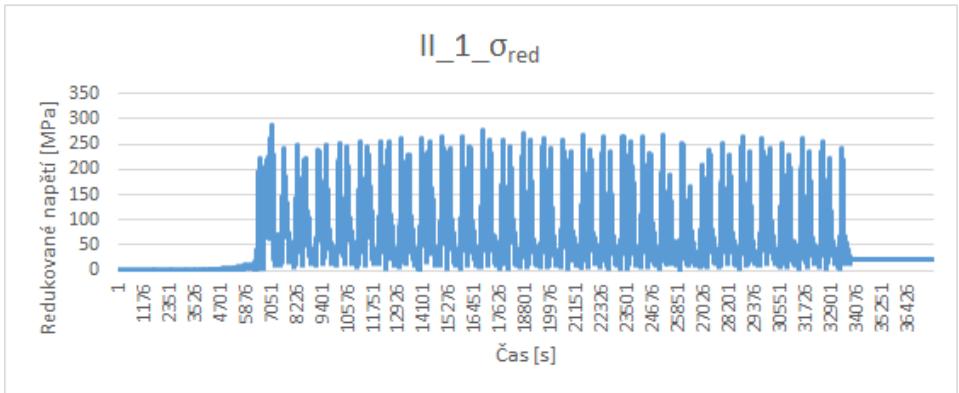
An example of a record is shown in Fig. 7-8.

Fig. 7-8: Recording of reduced stresses during the passage of the vehicle

Higher values of equivalent stresses were achieved on the outer arms of the flexible clamps (vertical and transverse movement of the clamp arms). The maximum value found is 288.43 MPa (record 12_46_122027_28 of the car). The maximum value of the equivalent stress of 159.92 MPa was found in the middle part of the clamps (record 16_00_730_730_podbíječka_pušl_podbíječka).

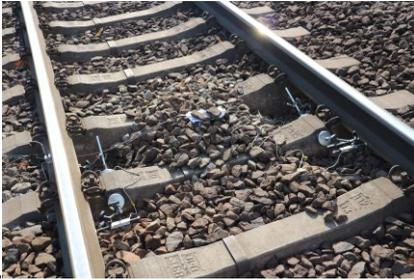
Measurements of rail strip displacements relative to sleepers were performed. A total of four resistance sensors were used to measure rail displacements on the sleeper, two sensors for measuring vertical movements, two sensors for measuring transverse rail movements, namely the NOVOTECHNIC TR50 sensors. Both non-elevated and elevated rail strip were measured - see Fig. 7-10 and Fig. 7-11. The sensors were connected to the measuring amplifier HBM DMC Plus (where the analog recording was digitized at the same time). Digitized voltage records were registered to a PC

Fig. 7-10: Location of displacement sensors

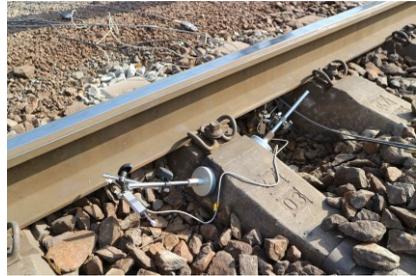
Fig. 7-11: Detail of the location of displacement sensors

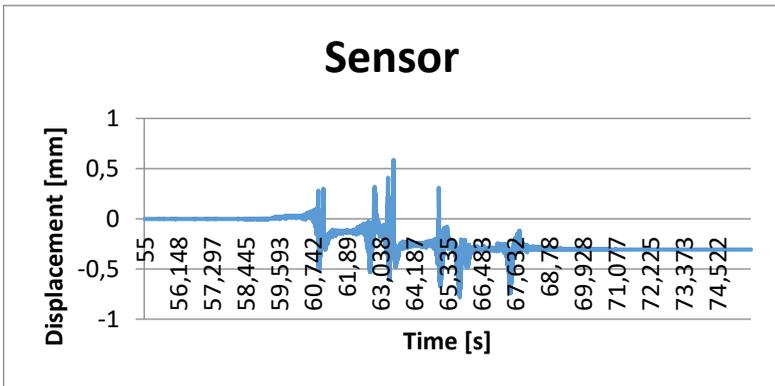
An example of a measured record is shown in Fig. 7-12.

Fig. 7-12: Rail displacement record

The maximum values of transverse displacements reached 0 mm to 0.71 mm, the maximum values of vertical displacements reached 0.24 mm to 0.61 mm. The minimum values of transverse displacements reached -0.19 mm to -0.82 mm, the minimum values of vertical displacements were -0.04 mm to -0.88 mm.

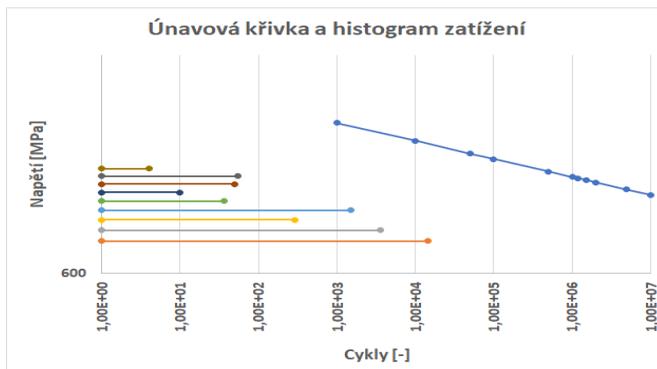
- 1) Identification of static prestress and adjustment of stress records from load sets by this static prestress.
- 2) Evaluation of transformed stress records using the two-parameter method of rain flow RF 2D - use specialized SW.
- 3) Transformation of the RF 2D matrix using Goodman's criterion into a 1D histogram with zero mean.
- 4) Determination of partial damage of individual sets - Palmgren-Miner hypothesis – see Fig. 7-13.

Fig. 7-13: Fatigue curve and load histogram

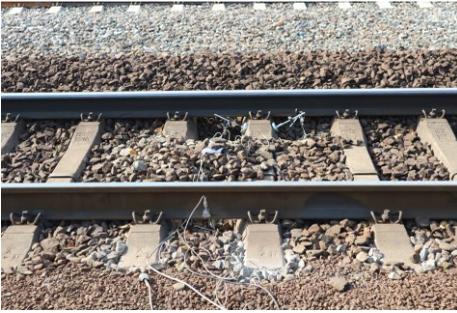
Acceleration measurements were performed. An inductive acceleration sensor HBM B12 / 500 was used for the measurement, which was attached to the base of the rail (non-elevated rail strip) - see Fig. 7-14 and Fig. 7-15. The sensor was connected to the measuring amplifier HBM DMC Plus (where the analog recording was digitized at the same time). Digitized records were registered to a PC via the HBM Catman SW. The sampling frequency for the measurement was 600 Hz.

Fig. 7-14: View of the measuring point

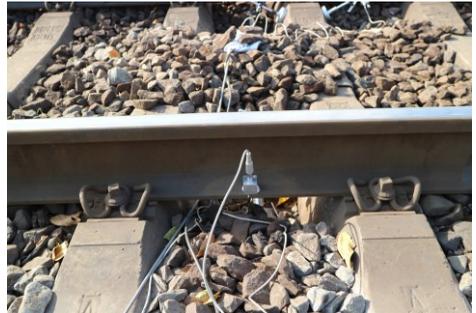
Fig. 7-15: Detail of acceleration sensor location

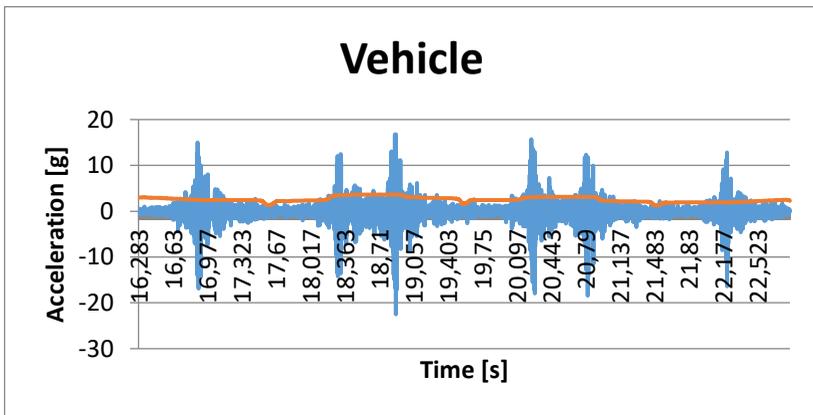
The results are recorded graphically - see Fig. 7-16, compared with the results of previous measurements. The maximum value of acceleration was measured 21.53 g, the minimum value was then measured -25.34 g. The accelerations are comparable with the results obtained in the dissertation [6] for the same type of fastening, i.e. W14.

Fig. 7-16: Recording of vehicle acceleration, including RMS display

From the records, the effective values of the RMS acceleration were calculated in the NI Diadem 2014 program, which have a greater telling value of the energy content of the acceleration than the local maxima - see the red

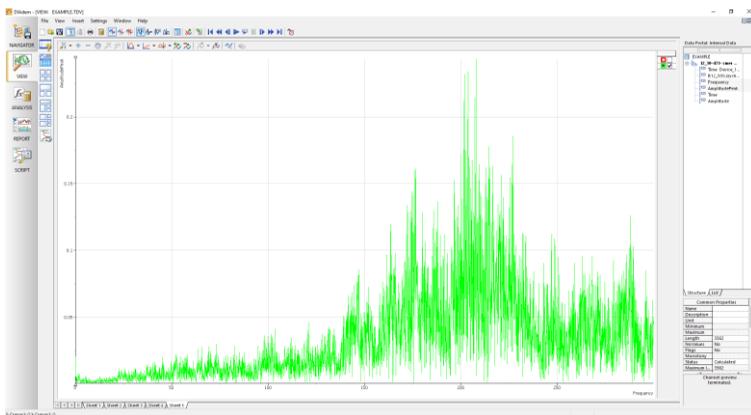
It was found that the peak acceleration values in the frequency domain coincide with the calculated slip wave bands.

Fig. 7-17: The result of the FFT analysis of the acceleration record when the vehicle passes

An FFT analysis was then performed from the effective power density of the RMS acceleration. Both steps were implemented using the NI DIAdem 2014 program. If the values given in Annex C of ČSN EN 50125-3 are compared with the values of the FFT analysis of effective acceleration power densities, the values found are smaller than the values required in the standard.
